**TFTR D&D Project: Final Examination and Testing
of the TFTR TF-Coils**

by
Irving J. Zatz

January 2003

**PRINCETON PLASMA PHYSICS LABORATORY
PRINCETON UNIVERSITY, PRINCETON, NEW JERSEY**

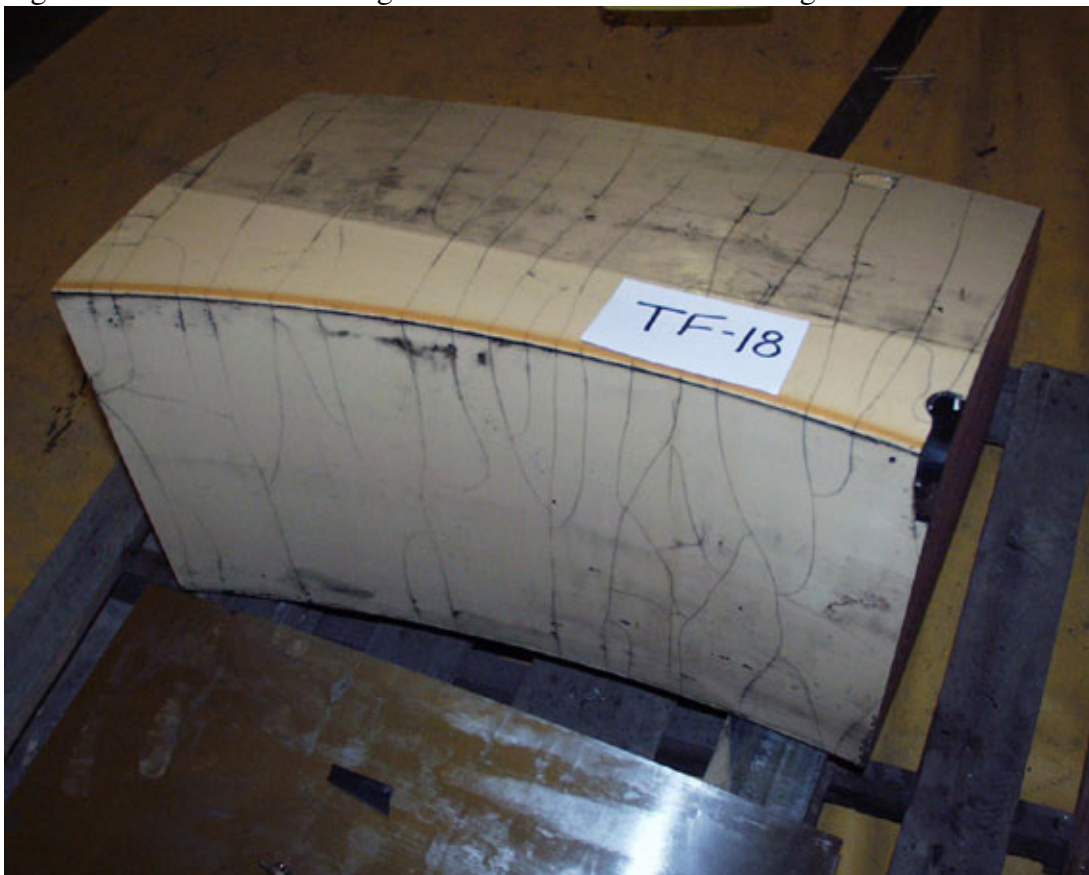
Figure 8 - Minor cracking in TF #18 nose section potting compound

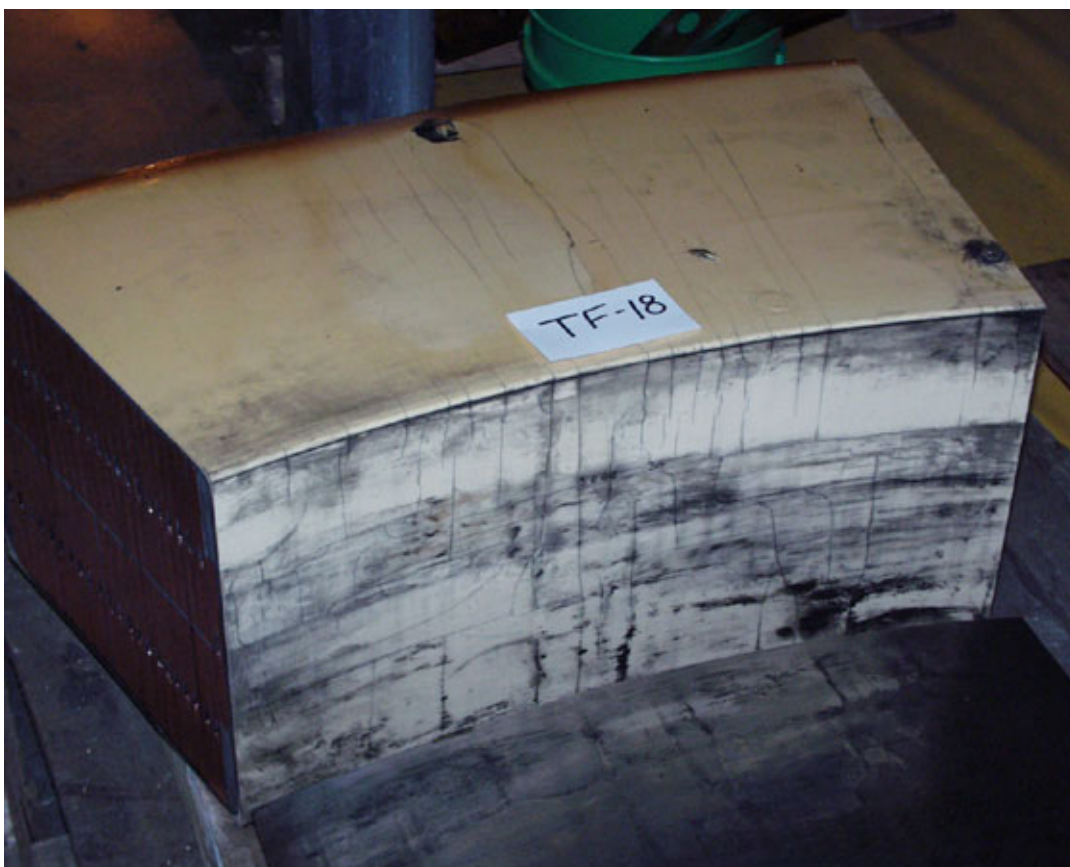
Figure 9 - Minor cracking in TF #18 back leg section potting compound

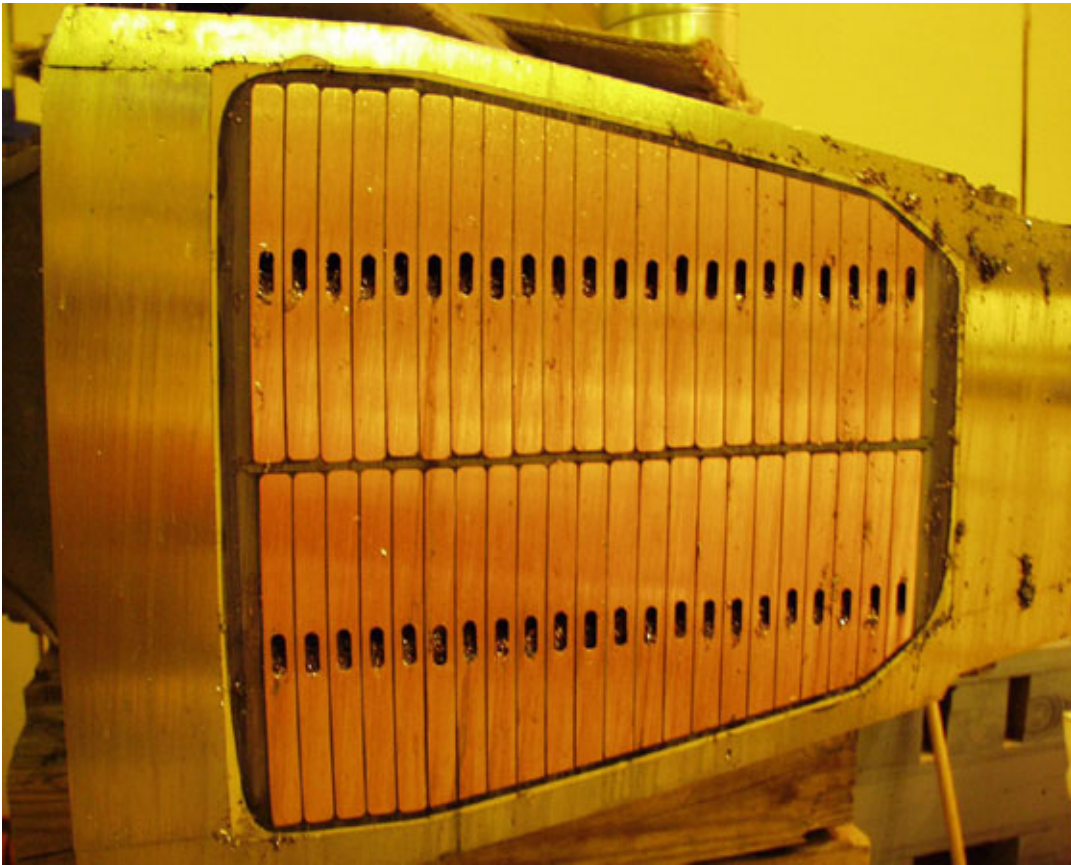
Figure 11 - Slight turn-to-turn misalignment

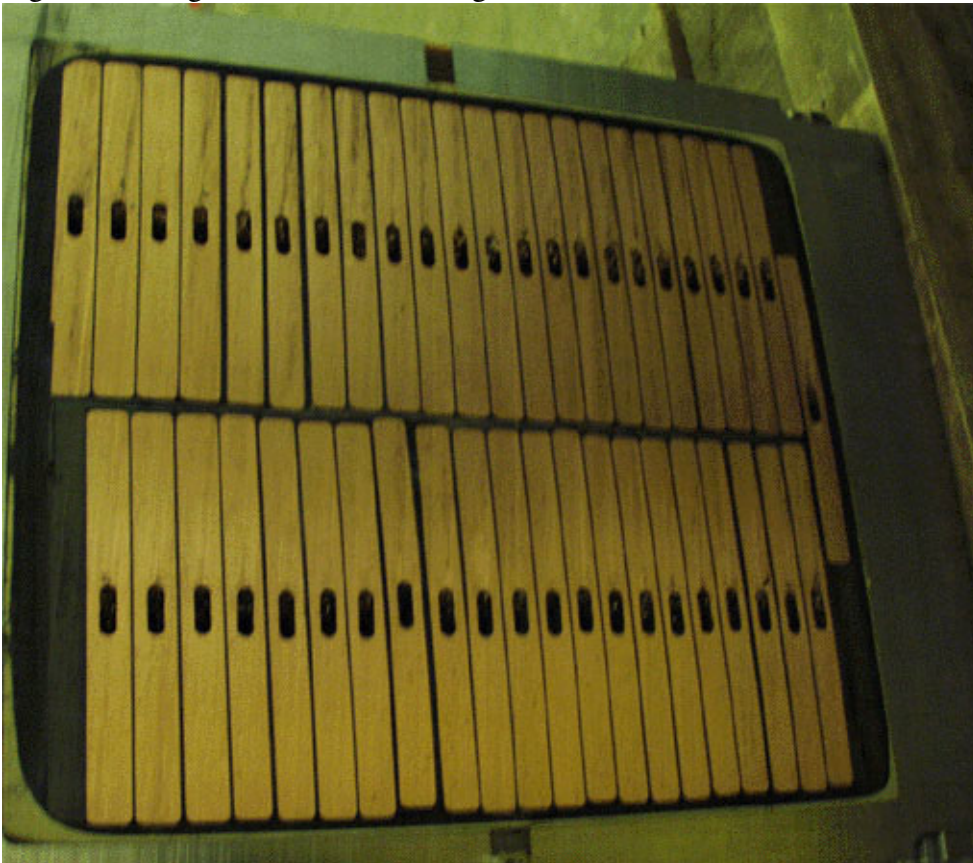
Figure 12 - Slight turn-to-turn misalignment

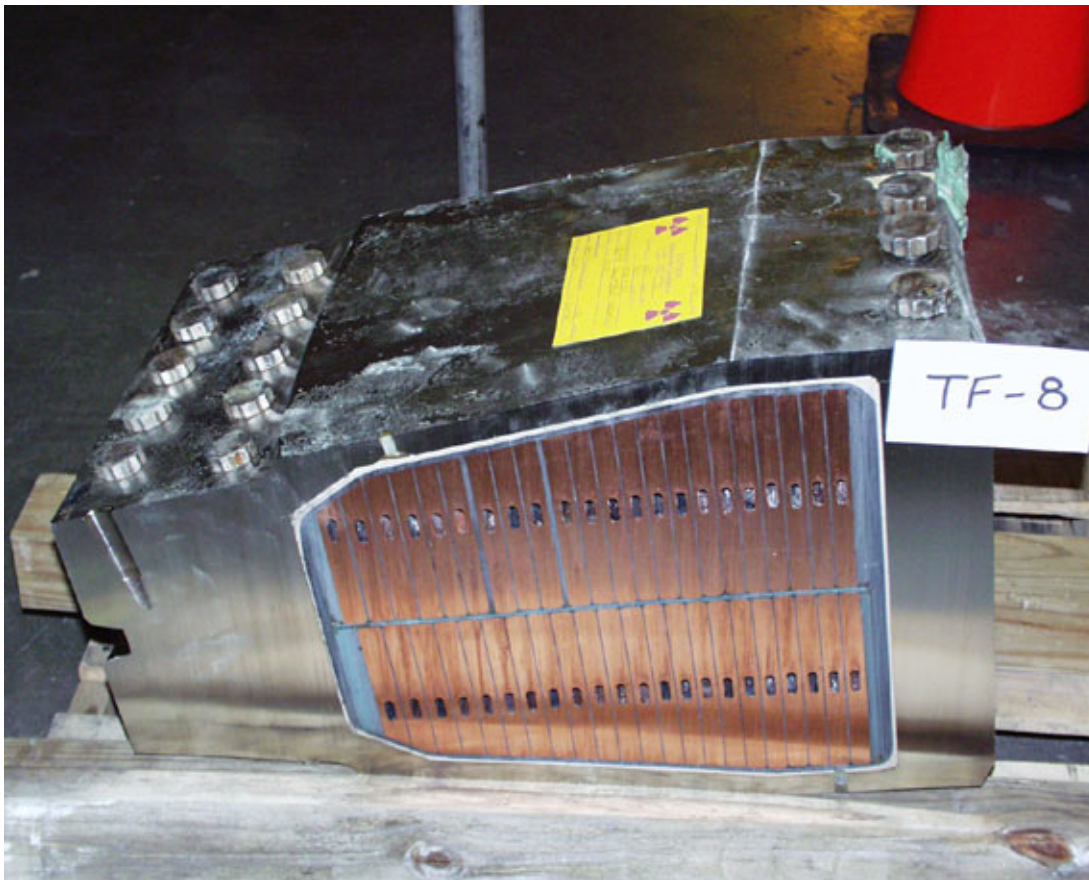
The D&D staff working in the TFTR Test Cell were alerted to observe the TF coils for anything that seemed different or unusual. They observed and reported that TF coil #8 was different. Up to TF #8, which was cut after TF's #3 & 18, each cut of a TF coil on the Marvel saw averaged 5 to 6 hours. This included cutting through the entire coil and case cross section. Early on, cuts were taking even longer because cutting through the Inconel 718 case bolts added a significant amount of time. Recognizing the bolt issue led to a policy of removing all bolts along a cut line in order to expedite the process. The

first cut of TF #8 took approximately one hour. Close examination of the cutting procedure indicated that the saw band speed was slower, but the usual procedure had been followed otherwise. Given the unusual circumstances, it was decided that a small section of the TF #8 nose was to be set aside for material testing (Figure 17). The second cut to remove this segment took longer than one hour, but with the slower band speed, still took far less than the average 6 to 8 hours. All TF coil cuts from that point forward were made at the slower band speed and the average cut time dropped to 2.5 to 4 hours each, but none came anywhere near the one hour it took for the first TF #8 cut. This anomalous event justified the closer examination that followed for TF #8. Saw blade quality was another possible variable that may have influenced the cut time. Normally, a new saw blade was used for every TF coil cut made during the D&D program. It was possible that the blade used for the first TF #8 cut was of exceptional durability and sharpness. Regardless, TF #8 was to be part of the material test program along with the segments cut from TF #3 and #18.

Figure 17 - TF #8 nose section

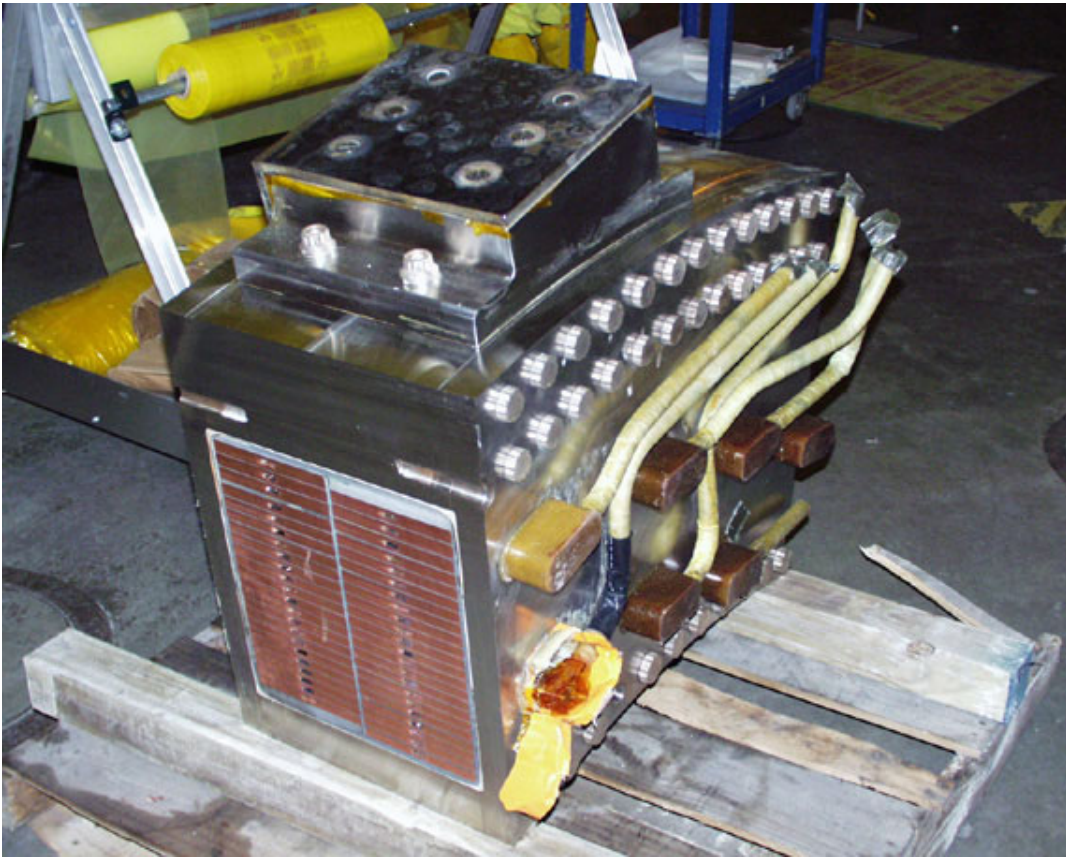
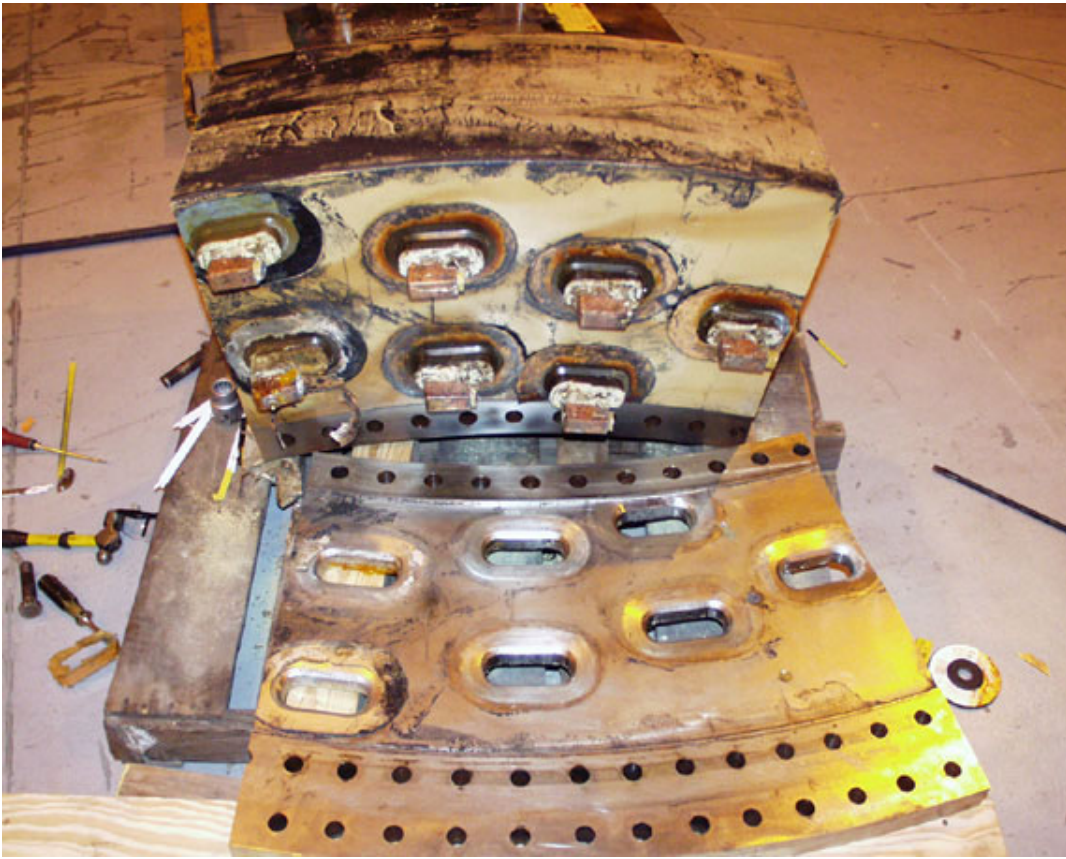
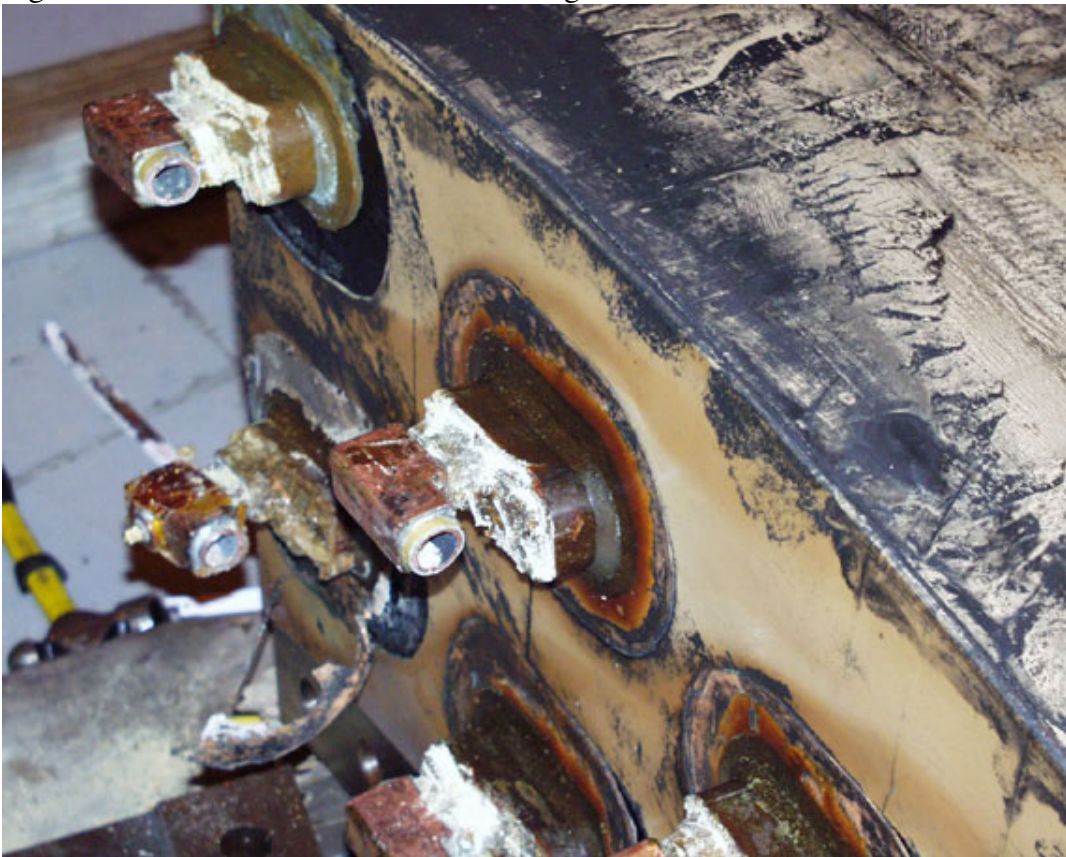
Figure 19 - TF #3 water fitting coil section

Figure 21 - Disassembled TF #3 water fitting coil section

Figure 22 - Close up of TF #3 water fittings with partial removal of insulation

With the TF #3 water fitting section set aside as part of the D&D project (Figures 19, 21, 22), actual leaking fittings could finally be extracted and subjected to a rigorous metallurgical evaluation and analysis. To be consistent, both vendors that conducted the prior work were contacted about regarding the opportunity to do the follow-up work on the TF #3 fittings. Unfortunately, one vendor (Structure Probe) declined due to their policy of not handling activated materials. The other vendor (City Testing and Research Laboratories) was prepared to examine these fittings.

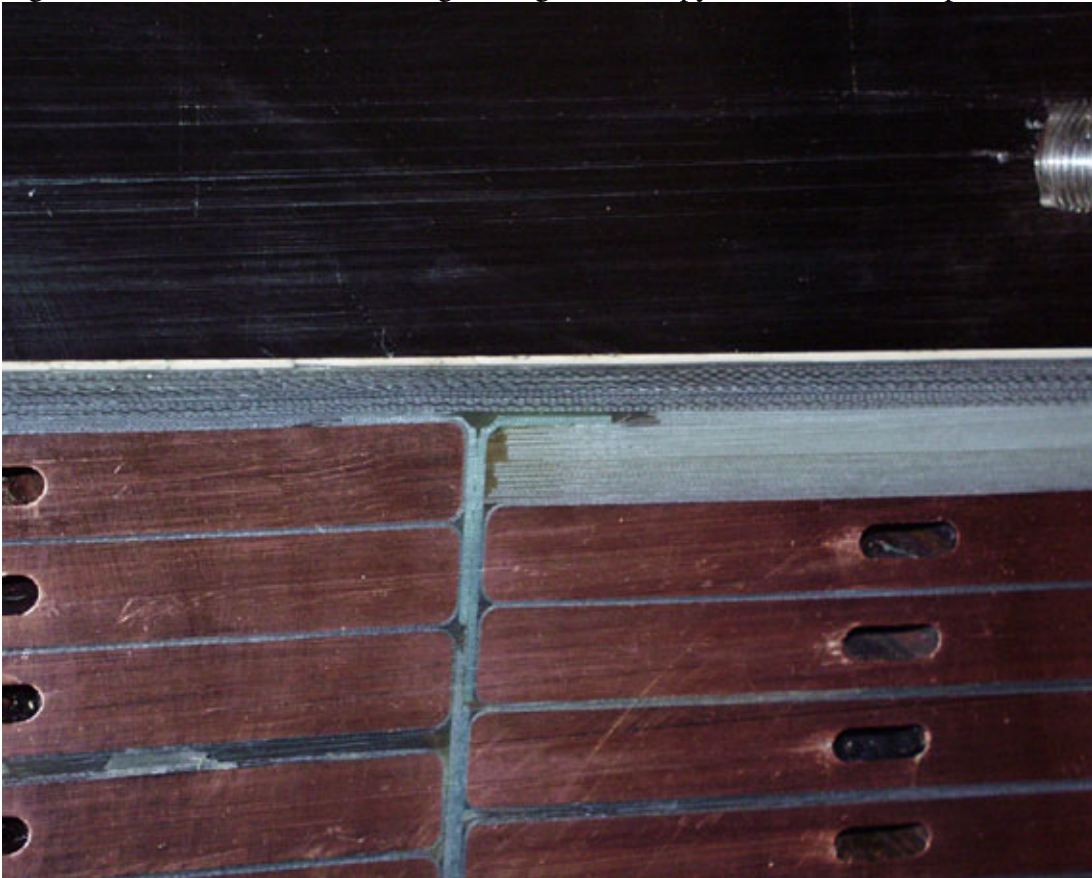
The visual inspection of the coil bundles, as seen in prior figures and close-up in Figure 32, gave every appearance that the coil was fully bonded because of the pristine condition of the copper, insulation material and epoxy. There were frequent instances during actual turn-to-turn separation where the turns were indeed well bonded and were extremely difficult to pry apart. But there were also instances where the pancake turns separated with significantly less effort. In fact, in some instances, the turns separated with hardly any effort with the epoxy bonded to only one copper turn. In other cases, the epoxy and insulation apparently failed to bond to either adjacent turn. The copper turns gave every appearance of proper pre-treatment and the integrity of the epoxy and glass tape layer was observed, yet turn-to-turn bonding either never occurred or did not persevere

Figure 32 - Extreme close up of insulation where tape layers can be distinguished

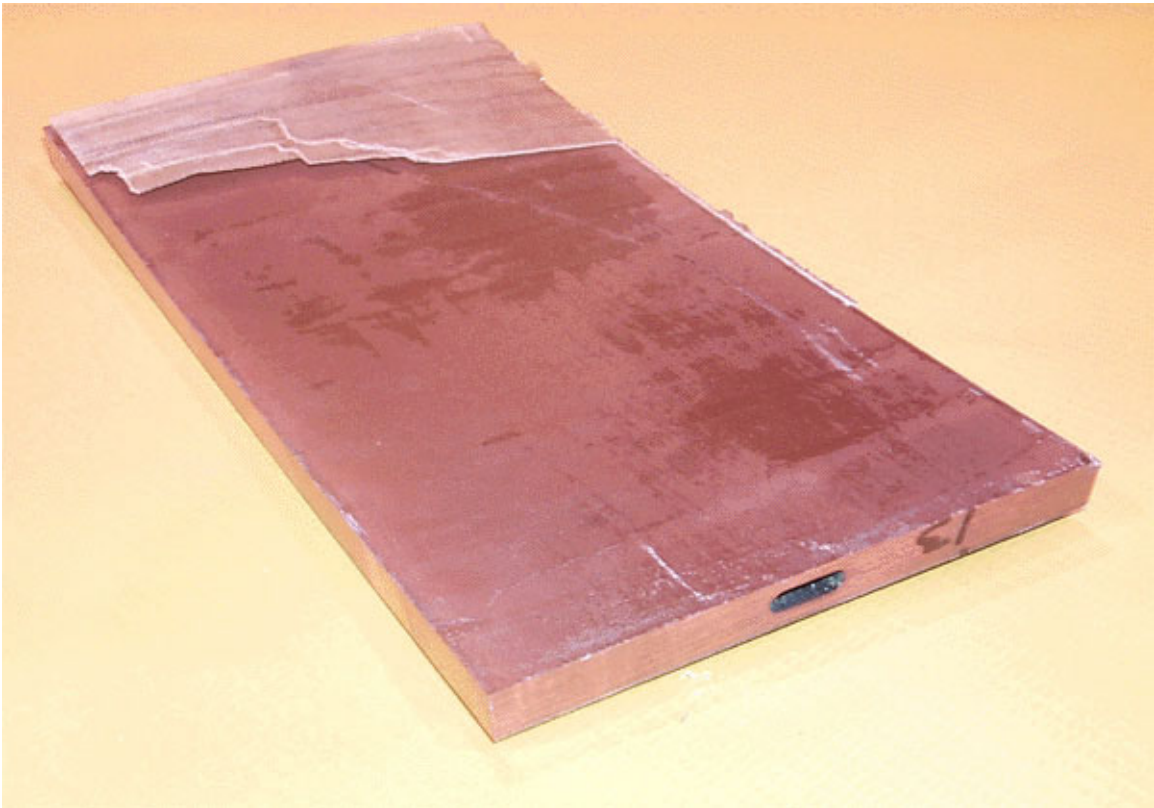
Figure 33 - Bonded tape delaminated from copper turn

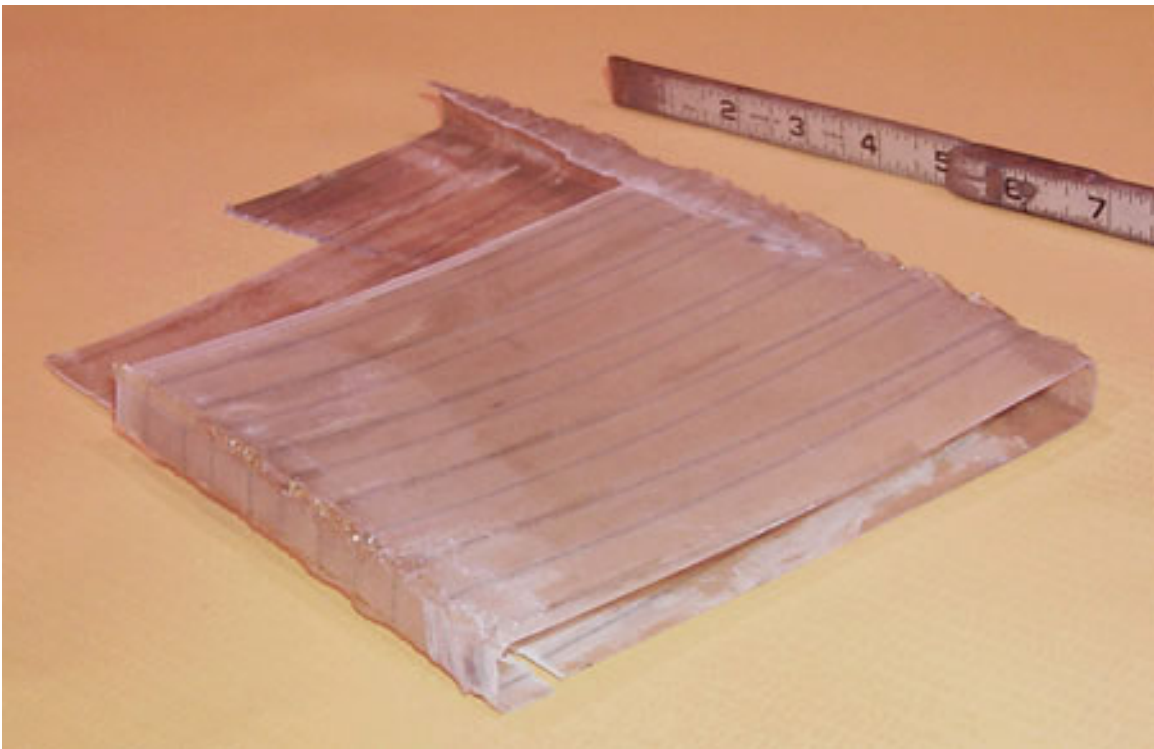
Figure 34 - Sleeve of bonded glass fiber tape where copper turn slid out

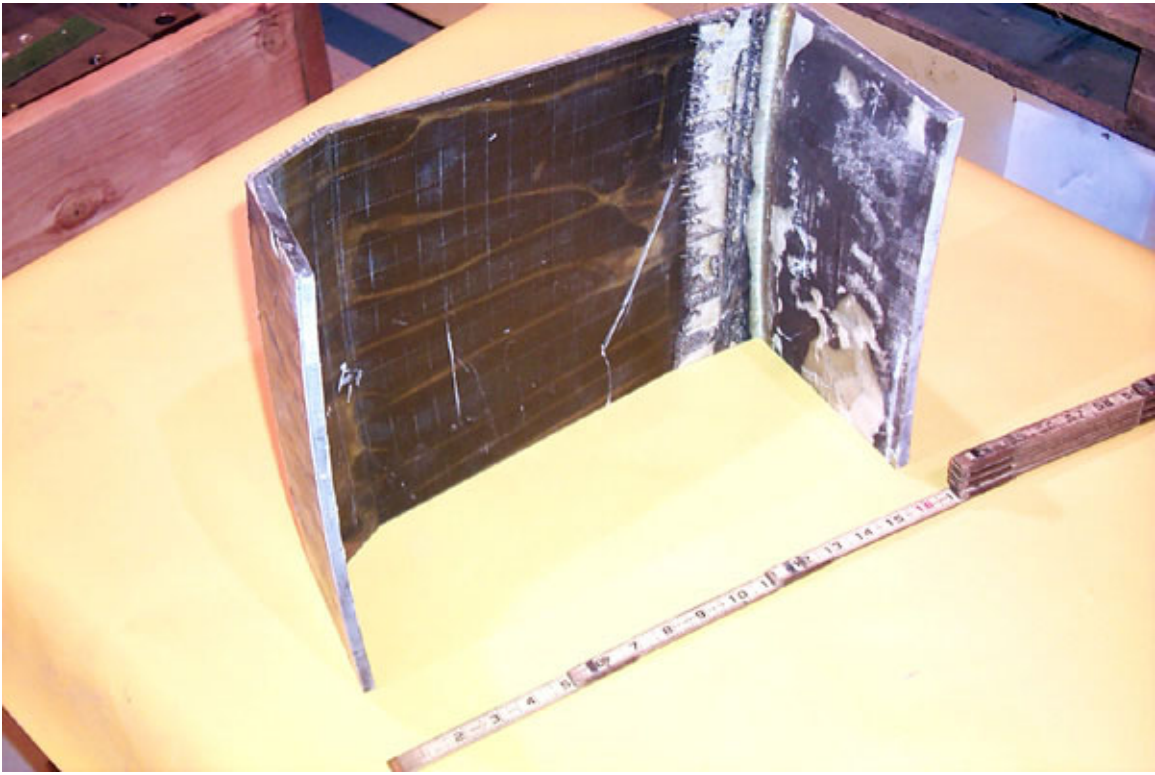
Figure 35 - Large section of ground wrap insulation which easily separated from the coil bundle

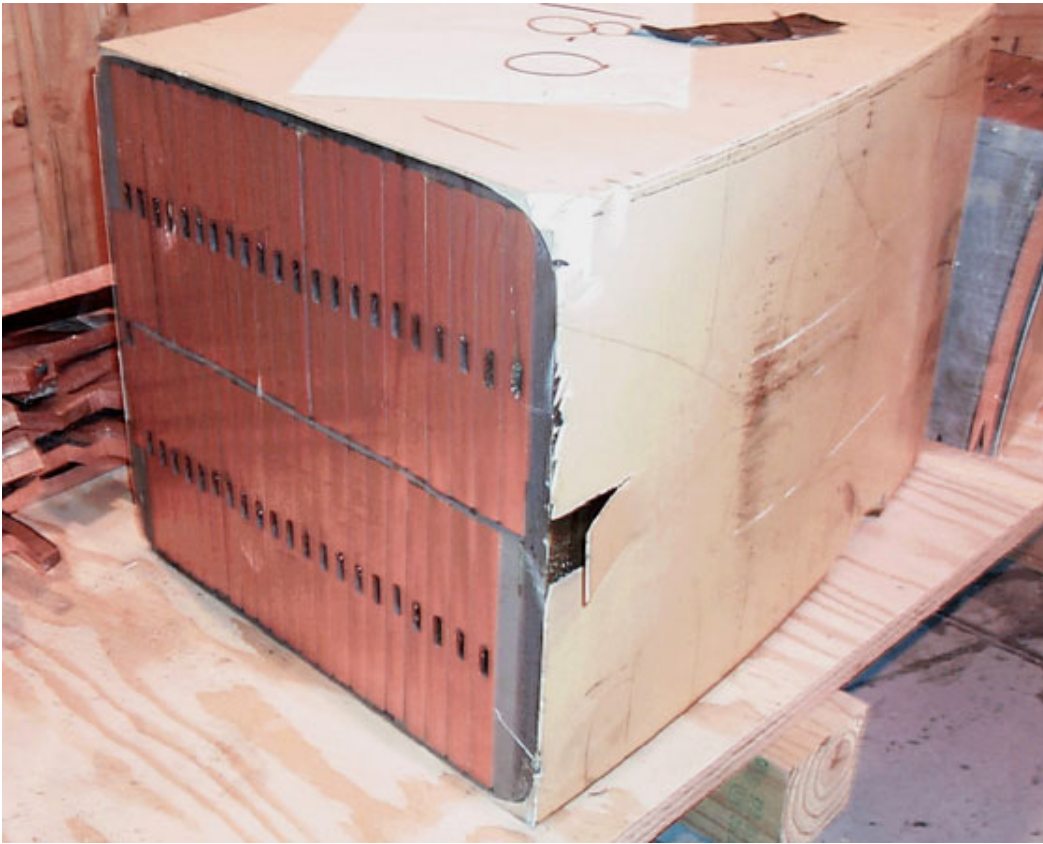
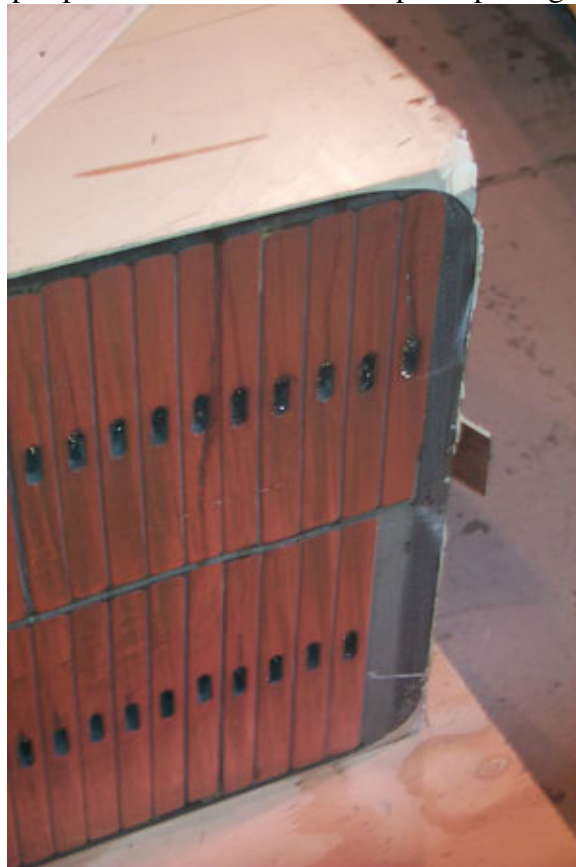
There was one additional observation made during the dismantling of the outer leg coil bundles. A thin strip of copper, approximately one millimeter thick and approximately one inch wide, was found embedded between the outerwrap and potting compound of each coil bundle centered between the pancakes (Figures 36 & 37). This strip of copper is the ground plane electrode that electrically connected the coil’s ground plane to the case.

Figure 36 - Copper strip separated from the outerwrap and potting compound

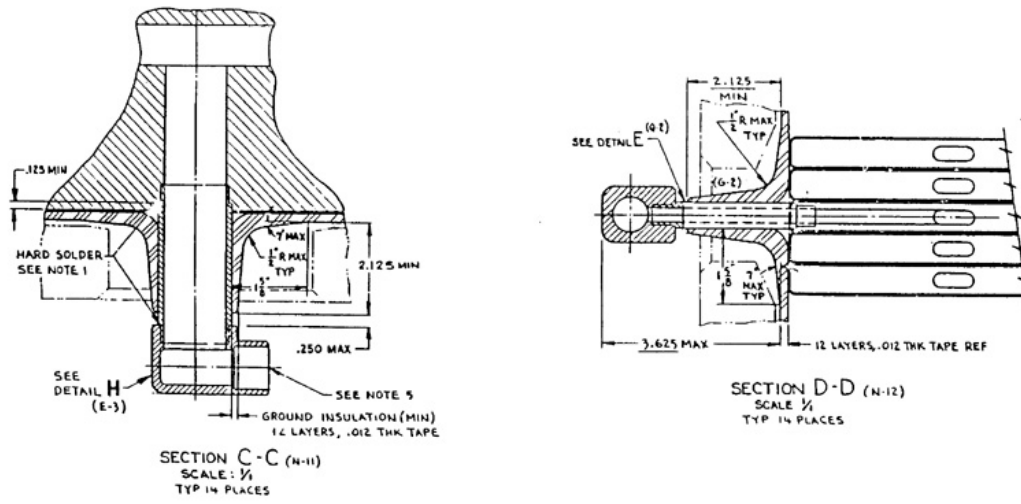
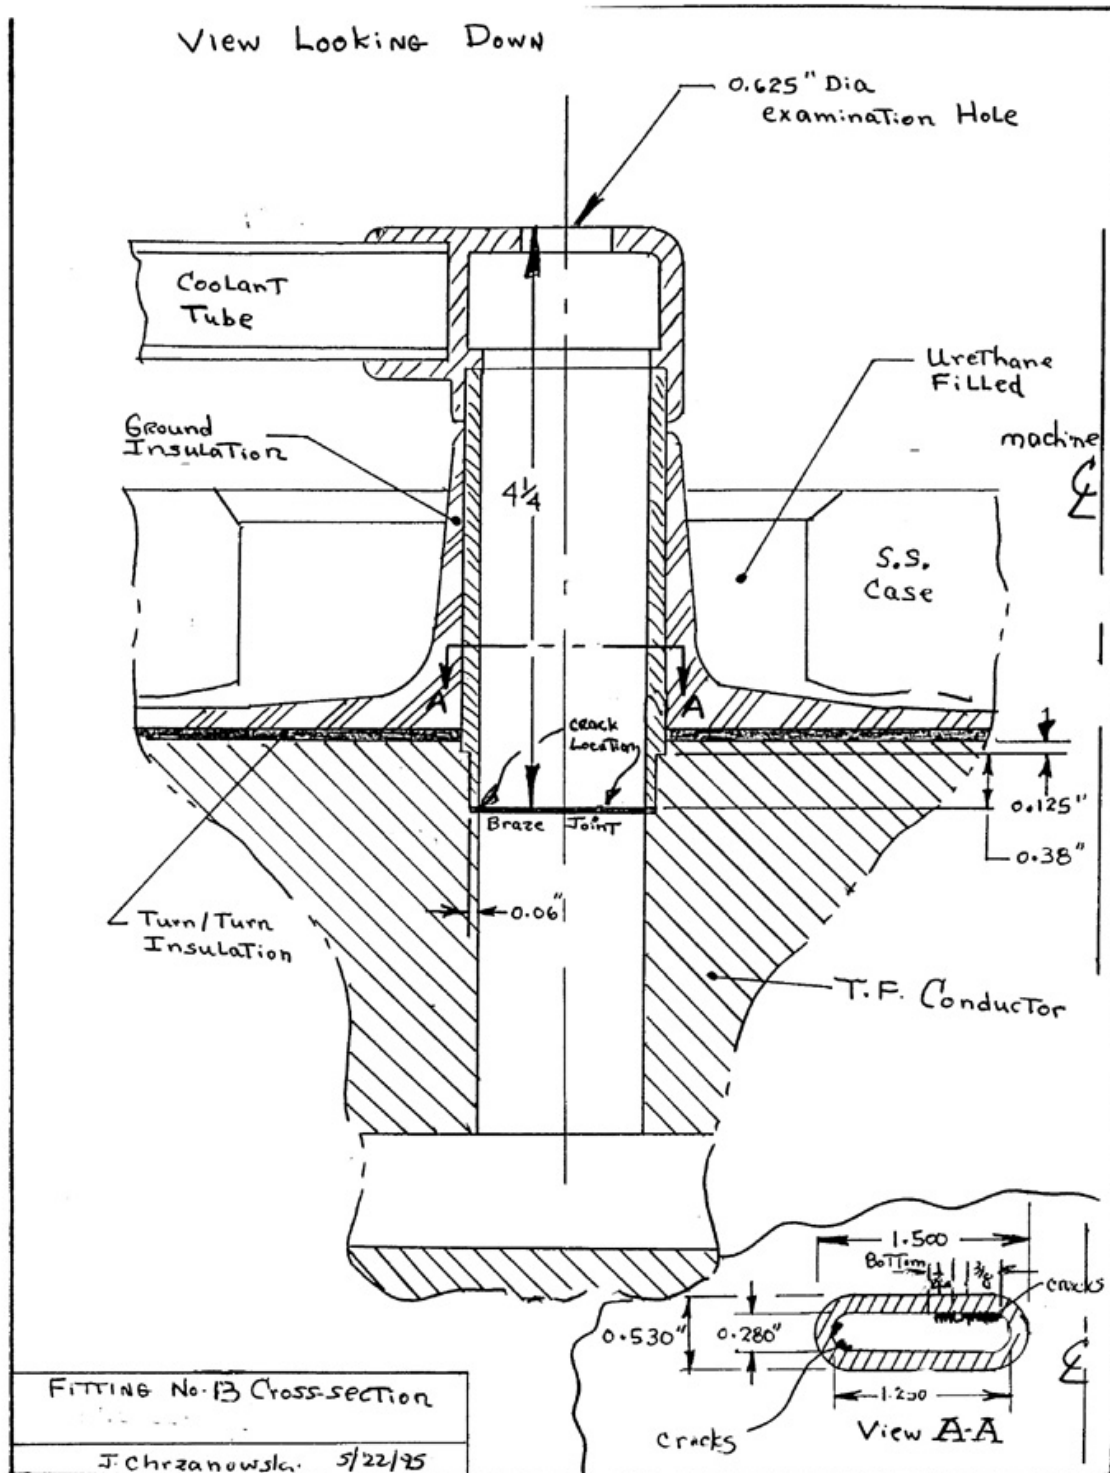
- Water fitting 3 had an unresolved leak. No defect had been found.
- Water fitting 13 was known to have cracks in the vicinity of the brazed joint connecting the water fitting outer tube to the main body of the coil (Figures 48 & 49). Attempts had been made to patch these cracks in-situ, but that effort was never completely successful.
- Water fitting 14 was never known to have a leak and was to serve as a reference for the metallurgical tests.

Figure 48 - Typical TF Coil Water Fitting Detail

Figure 49 - Schematic Detailing TF #3 Water Fitting Crack Observations

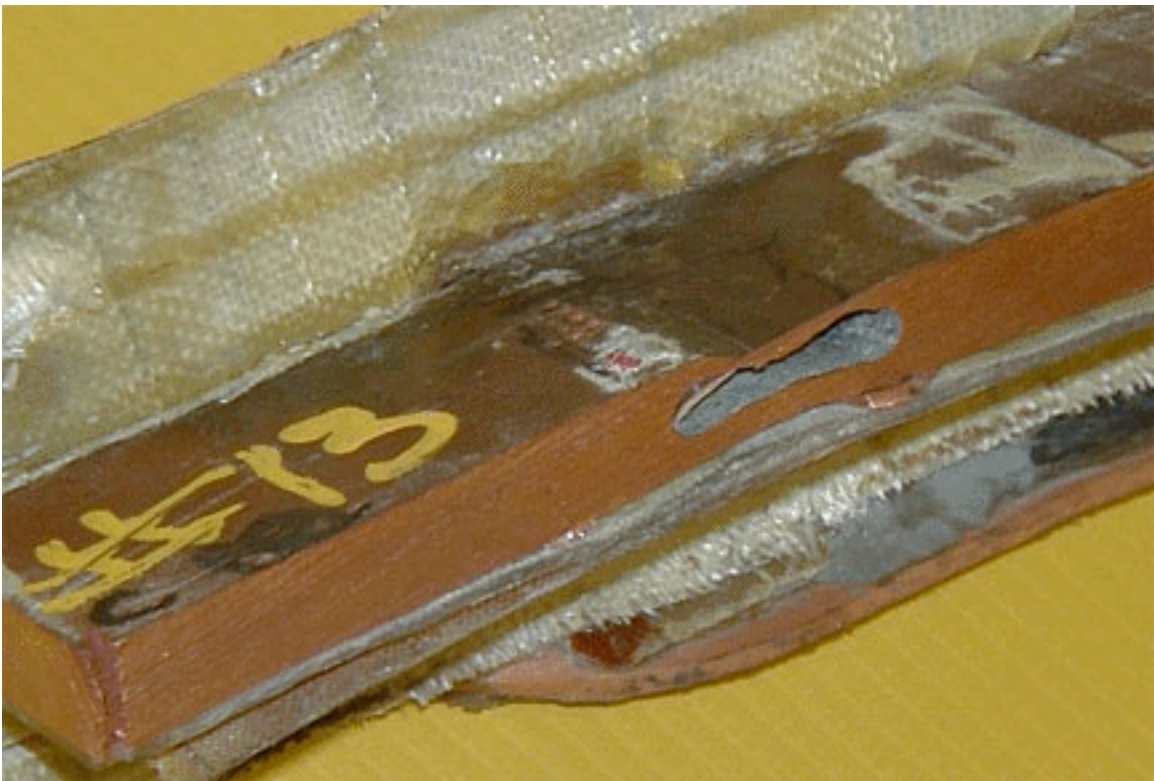
It was upon the return of these cut-up tested water fittings that the probable cause of many of TFTR's water fitting leaks became apparent. Figure 51 is a view of the fitting 13 crosswise cooling channel linking the external water fitting to the extruded cooling channel in the body of the winding. Not only is this crosswise channel severely deformed, but the channel itself is not centered within the thickness of the turn, leaving a very thin wall of copper. In this case, the deformation in the cooling channel has resulted in a thru-crack in the turn. This deformation was almost certainly caused during the manufacturing process. The sequence of brazing the fitting in the copper plate probably annealed the local copper in the crosswise channel. As one moves away from the braze

area, the copper transitions back to hard (32 ksi yield) copper. The copper plate is then wound into the coil turn, and buckling in the annealed crosswise channel can easily occur as the metal acts like a hinge.

The other two tested fittings also had this same buckled phenomenon, however, the crosswise cooling channel was centered better in those turns, avoiding a thin-walled thru-crack. It is not hard to imagine that out of the 280 water fittings on the TFTR TF coils, several others may have had leaks where the annealed copper crosswise channel was not properly centered in the turn.

Figure 51 - TF #3 - Fitting 13 - Deformed Crosswise Cooling Channel
